Manhole Inspection Summary

Manhole # S33YY_002MH

Insp Date: **4/16/07 10:49 AM**

Location Address: **3301 SAINT PAUL ST**

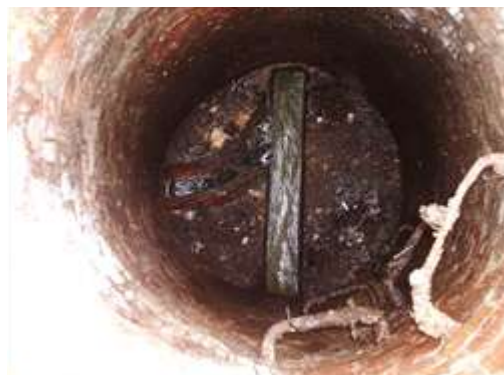
Top View

Corroded steps. Evidence of surcharge - Bench debris.

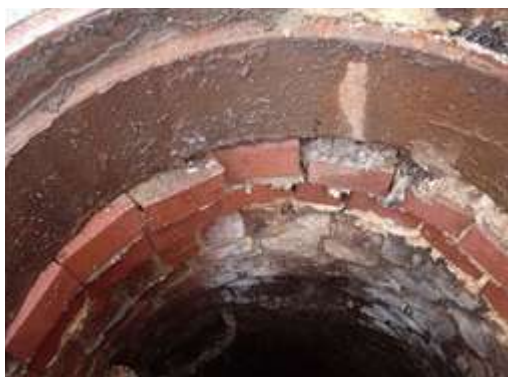
Defect

Frame leaks. Frame offset. Adjustment deterioration, loose brick and infiltration. Corbel infiltration.

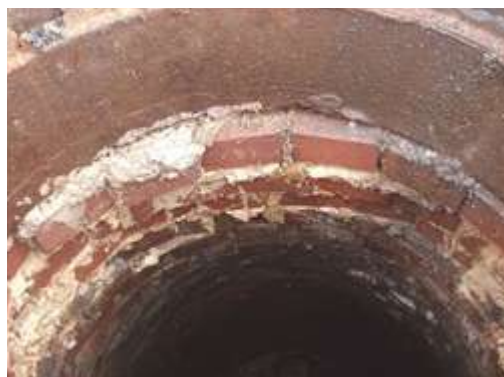
Defect

Frame leaks. Frame offset. Adjustment deterioration and infiltration. Corbel infiltration.

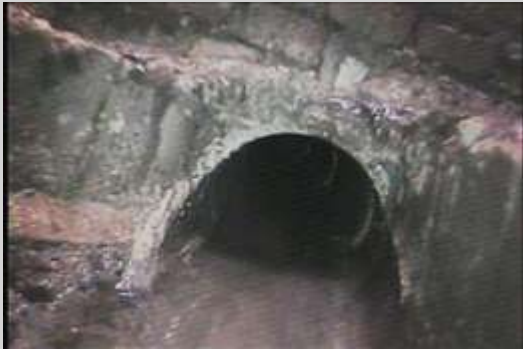
8 in. Circular Gravity Sewer Pipe Out @ 12 O'Clock

Barrel deterioration and infiltration.
